**Budapest University of Technology and Economics**  
**Department of Engineering Geology and Geotechnics**

**SLOPE STABILITY ANALYSIS OF ELEVATED SHORELINE AT  
BALATONFÖLDVÁR**

*Structural Engineering MSc Program*

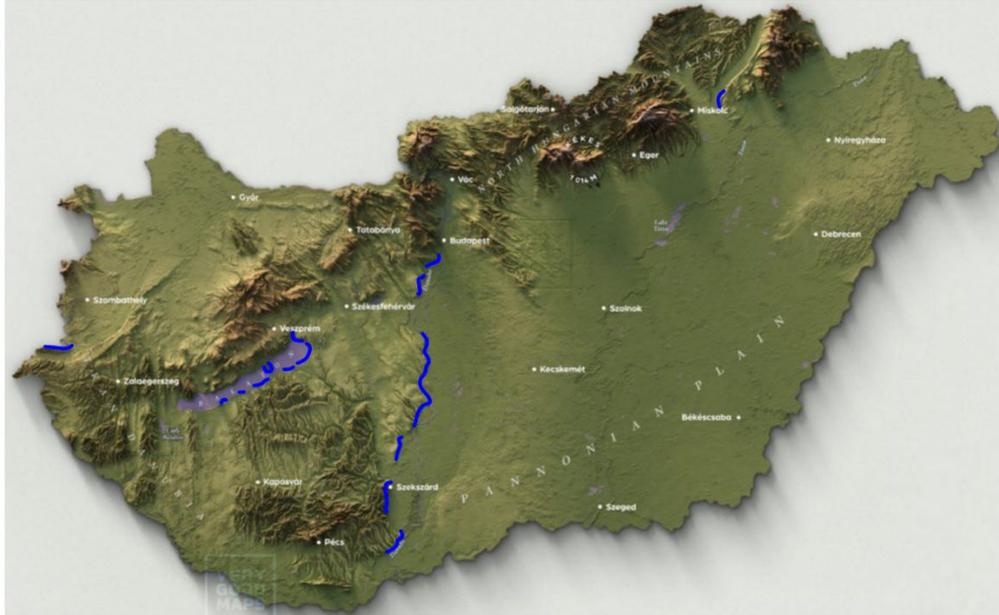
Figure.13 (High cliff locations in Hungary)[1]

In diverse locations across Hungary, hazardous loess cliffs are prominently observed, such as on the banks of the Danube, extensive stretches of Lake Balaton, and the southern periphery of Lake Fertő. Of these, the Hernád's elevated banks are the most dynamically active. The major area where the high cliffs can be found is marked in blue in Figure. 13.

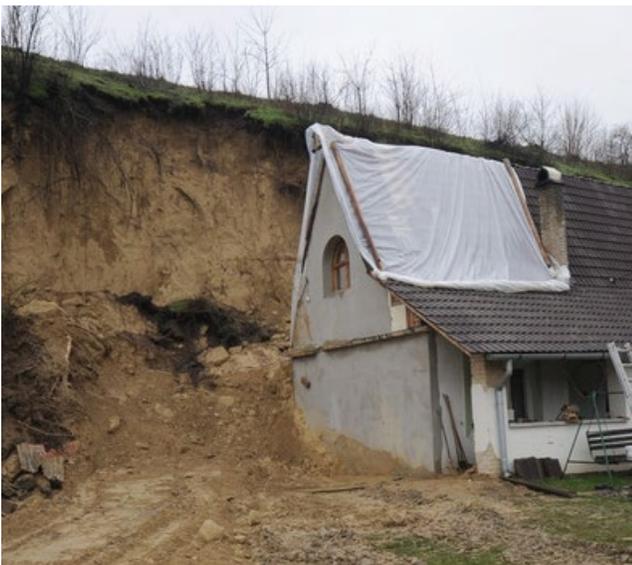
Figure.14 (Loess wall failure in Tolna Hungary. Photo by: Lendvai Péter)[2]

The location of these steep cliffs has become a concern as urbanization has moved closer to their vicinity. Today, houses, railroads, public works, and road networks can be found all within tens of meters of the sheer faces of these cliffs. In many cases, the monitoring and erosion maintenance of the cliffs has gone forgotten. This can lead to accidents and property damage such as what many homes faced in the Tolna and Verőcén districts of Hungary (Figure 14 and 15).

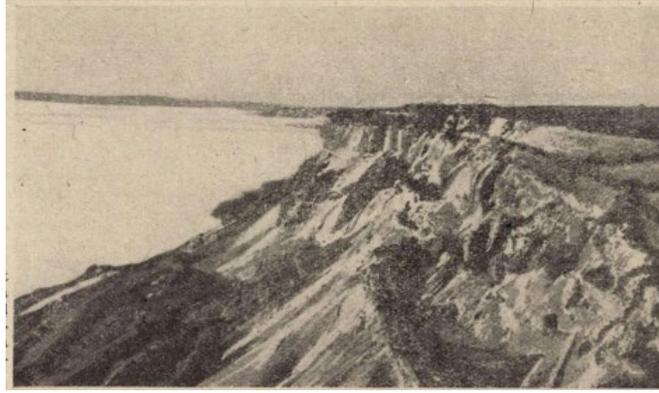
Figure.21 (Balaton Akarattya high cliff failure) [6]

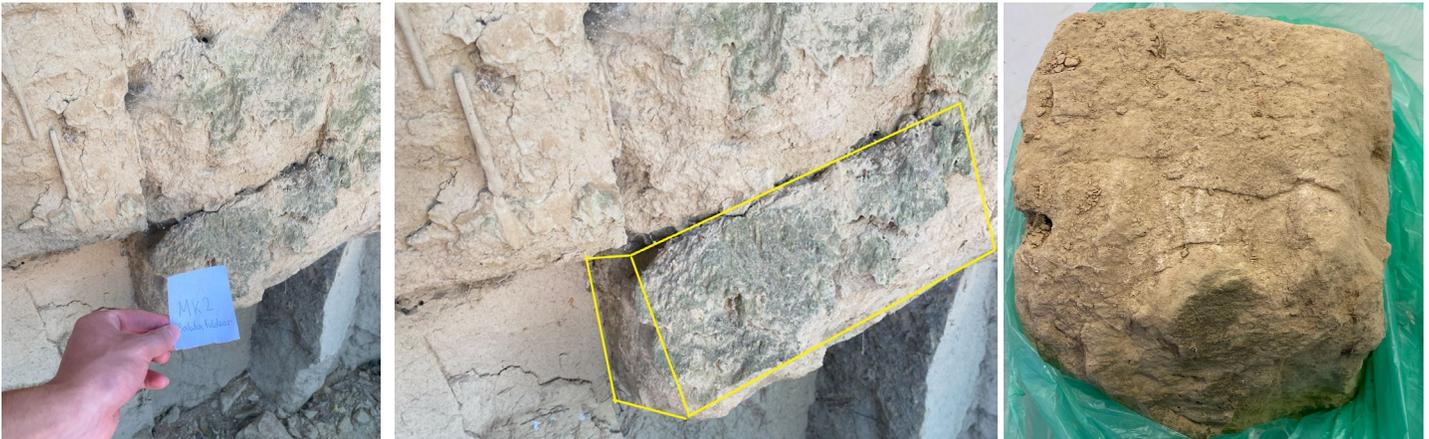
Figure.45 (Collected sample)

The sample location is indicated on the Site Plan with the MK2 marker. The location was at the top of the debris slope just at the start of the vertical cliff face (a sample was taken from the cliff face). The piece was chosen to collect a relatively large intact piece for sampling.

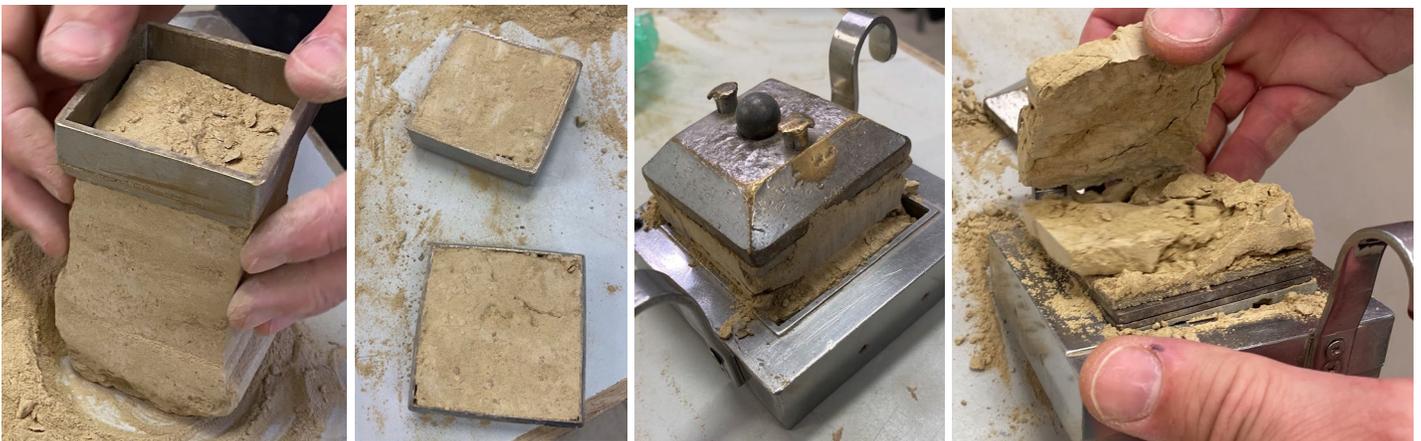
Figure.46 (Shear-box test)

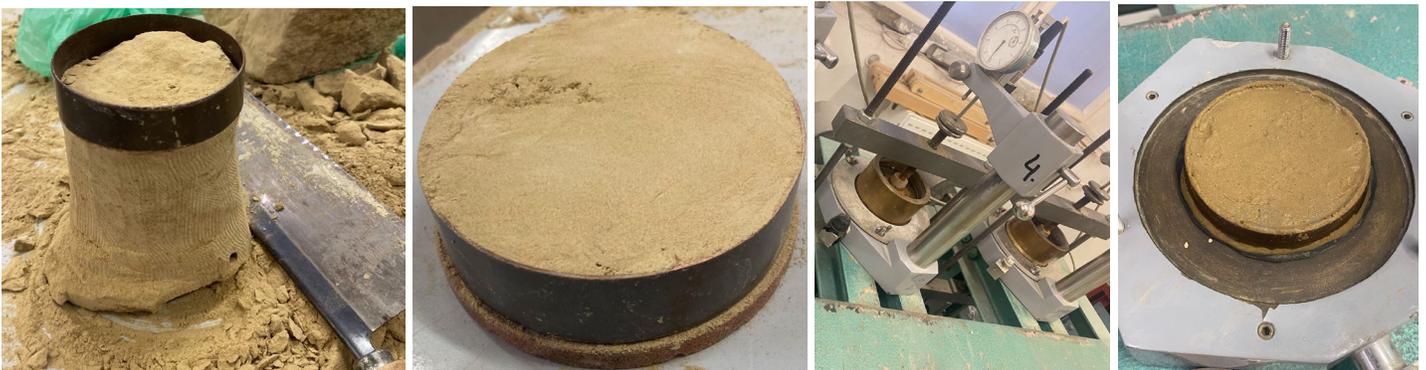
Figure.47 (Oedometer test)

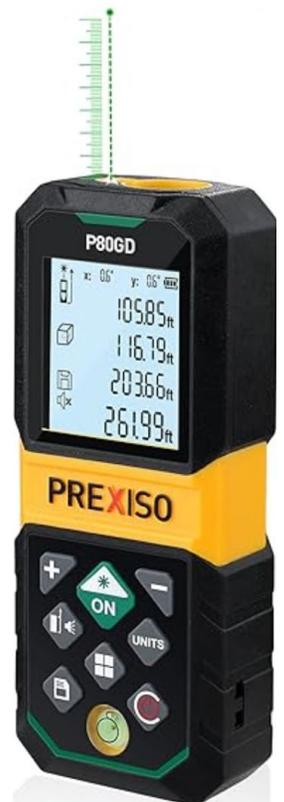
Figure.49 (Laser measure) [29]

The site inspection was conducted with a Lazer handheld distance measuring device (as seen in Figure. 49). Eight points were placed (seen on the site map) designated along the cliff encompassing the whole height range. These points were logged with their coordinate into Google Maps, allowing for a clear visualization of where the points lie horizontally from one another. The known base level of the road was established first, and then the distance between the points was measured vertically and horizontally from one another. This process was repeated from the bottom of the cliff to the top and then once more from the top of the cliff to the bottom, the values matched. Furthermore, the elevation data of the base and top of the cliff was referenced to geodetic measurements.

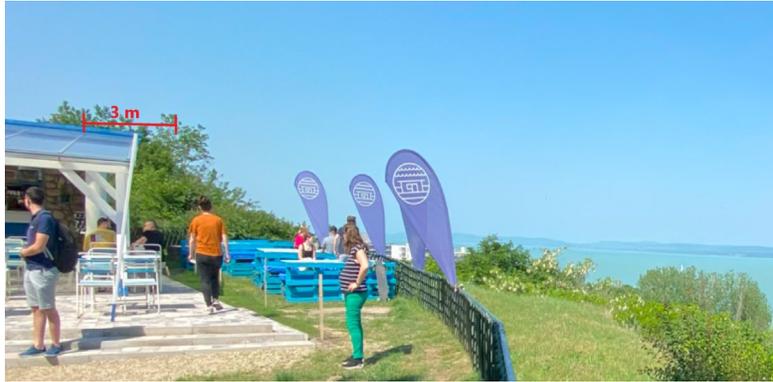
Figure.56(Structure nearest to cliff edge, Balatonföldvár)

Figure. 57, visualizes the closest structure on the edge of the 35-meter cliff in Balatonföldvár. The back edge of the building is only three meters from the shear cliff face. Local failures of the cliff could lead to a destabilizing effect, coupled with the overpressure of the structure leading to a catastrophic failure. The water runoff from the roof in case of heavy rain must be deposited into the central sewer system. Intense wetting of the loess near the edge of the structure (close to the cliff face) can be a compromising factor, as the loess loses cohesion drastically when wetted.

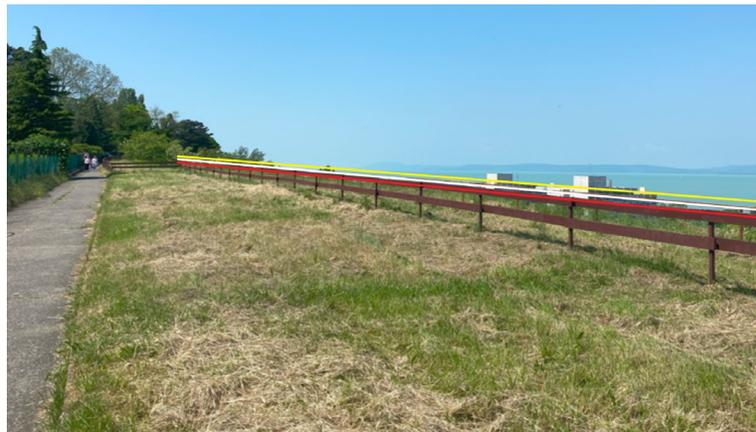
Figure.57(Protection rail cliff face)

Over the last 20 years, local deformations at the crest of the high cliffs have led to the detachment of protective railings from the edge. The yellow line (uppermost) marks the initial position of the oldest railing, which is no longer visible. The white line represents a railing that's likely to fall off the cliff face in the coming years, with parts already losing support due to localized cliff failure. The most recent railing (marked in red) is placed two meters behind the edge railing (white), acting as a visual indicator of the ongoing and progressive erosion of the cliff.

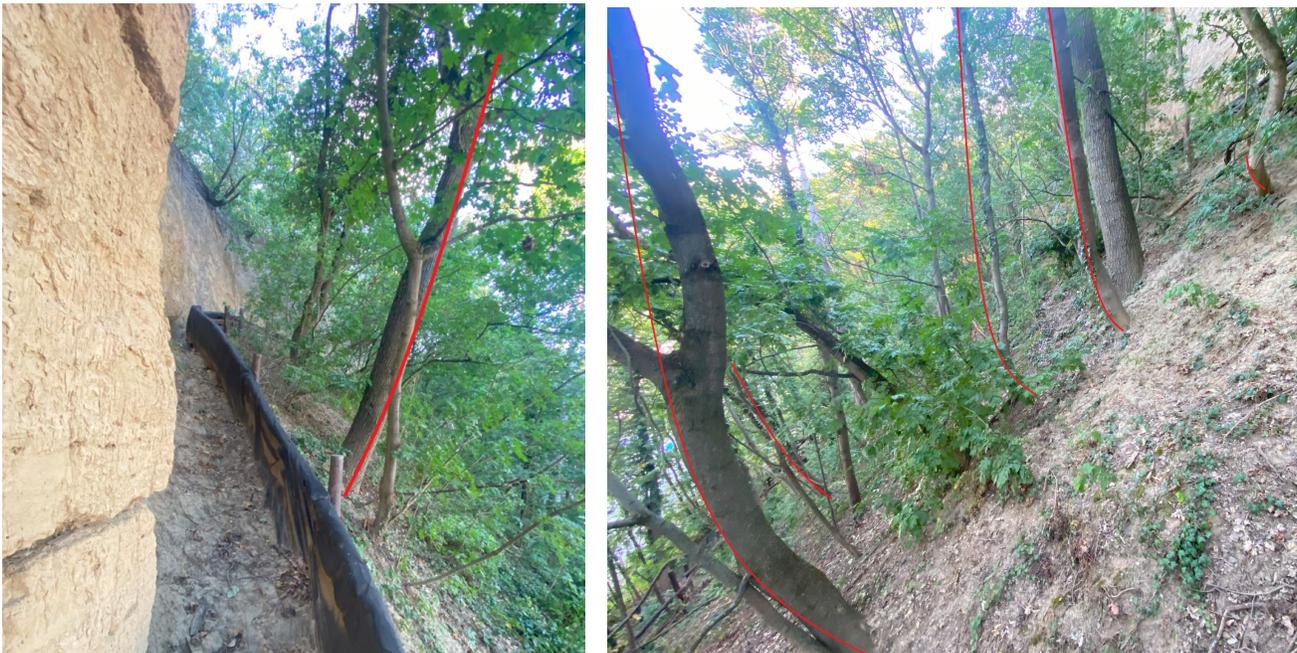
Figure.59 (Tree deformation seen on the debris slope)

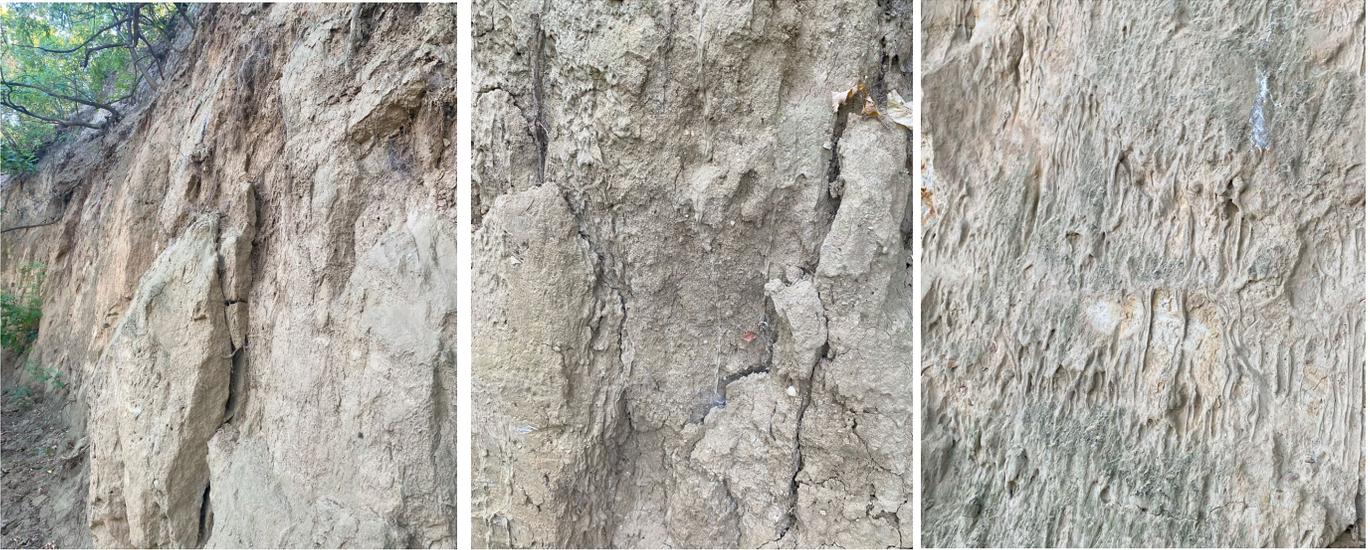
Figure.60(Loess cliff face close)

In the above three images (Figure. 61) the weathered surface of the cliff can be seen. There are larger pieces of delamination that can be found. Furthermore, veins of eroded/washed-away material can be seen covering large flat parts of the cliff face. Large cracks between the delaminated bodies of loess can be noticed. This is most likely due to freeze-thaw cycles and the expansive and contractive nature of the soil due to the clay content. The material was crumbly and easy to scrape off within the first 1.5 cm. However, behind the weathered surface, the loess is very dense, hard, and uniform.

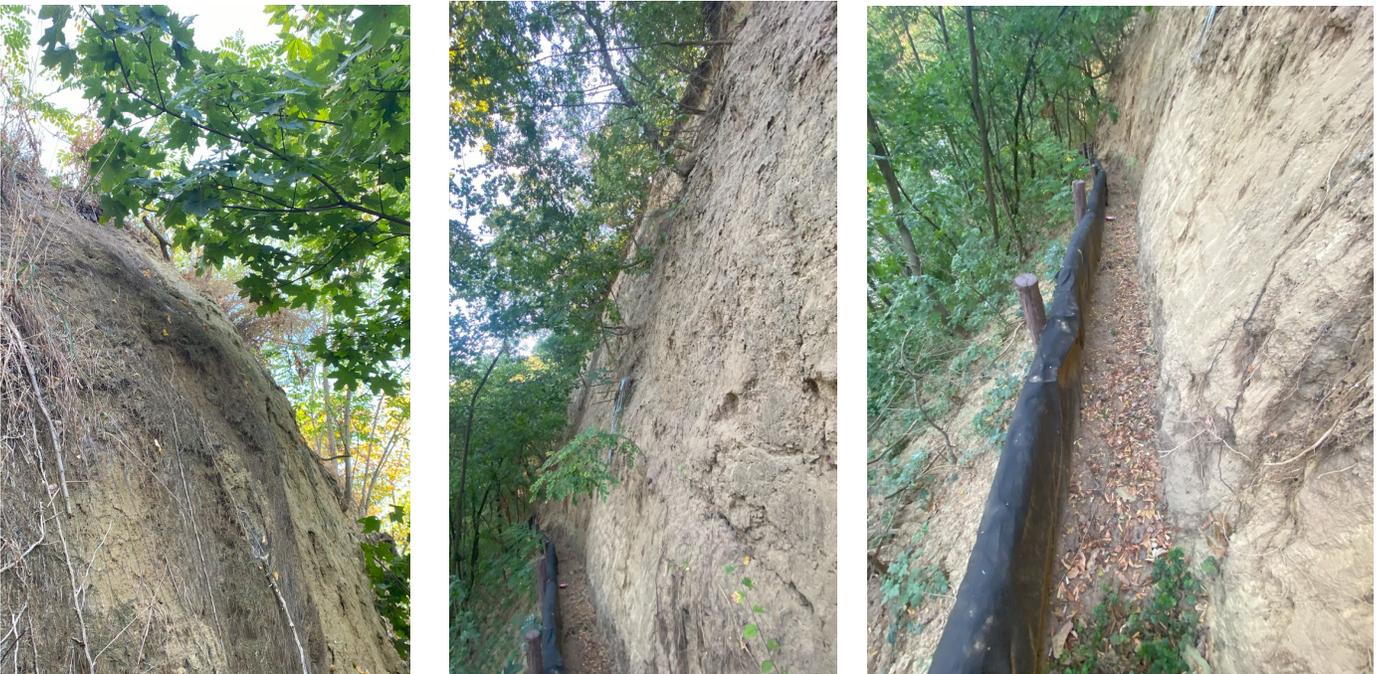
Figure.61 (Loess cliff face)

In the above image, we can see the vertical loess cliff face. The part starting from the base of the support fence can be considered as the debris slope. The cliff in parts has been reinforced by geo-mats, however, these are sparse and in bad condition. Channels of water runoff can be seen. In many locations, there are roots and vegetation present, which can increase the local stability of the wall. Visually the soil mass seems to be very uniform, it was difficult to identify any layering. This can be due to the high degree of weather that the loess face has experienced.
